# Manhole Inspection Summary

Manhole # S49AA\_006MH

Insp Date: **5/8/08 2:32 PM**

**Location** Address: **700 n lakewood ave**

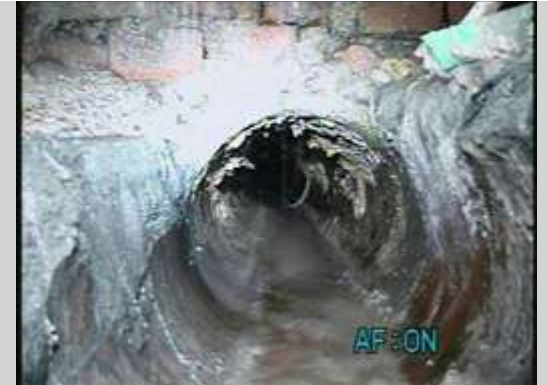
12 O'Clock Outflow

8 in. Circular Gravity Sewer  
Pipe Out @ 12 O'Clock

Deposits: ☒ None ☐ Mud ☐ Sludge ☐ **Debris** ☐ Grease

Infiltration: **None** Pipe Seal Cond: **Unknown**

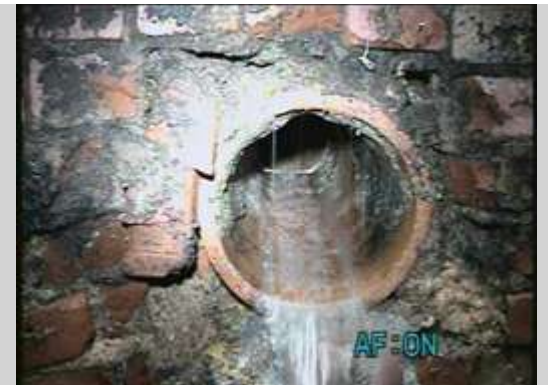
5 O'Clock Inflow

12 in. Circular Gravity Sewer  
Pipe In @ 5 O'Clock

Infiltration: **None** Pipe Seal Cond: **Unknown**
